CITY OF PORT LINCOLN

PARNKALLA TRAIL 10 YEAR STRATEGY 2008 - 2018

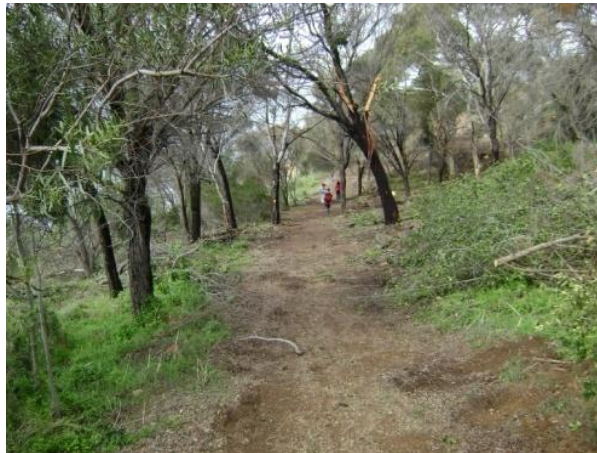
- Extensive infestation by Aleppo Pine's along majority of section between Information Bay and Axel Stenross Museum. This will be addressed this financial year through Council foreshore works program.
- Short sections of additional post and rail required to protect users from edge drop-offs.
- Scour protection required on steep downhill grades, drainage diversion options to include construction of berms to divert water or sealing. Sealing will also make grades easier to traverse. (see below)

Steep grade south of welcome sign

- 1.1 The full length be sealed at a minimum of 1.2m and preferably 2.0m wide along its entire length including scour control structures in steep sections. Improve site lines on sharp corners and install appropriate fencing along unprotected cliff edges.**

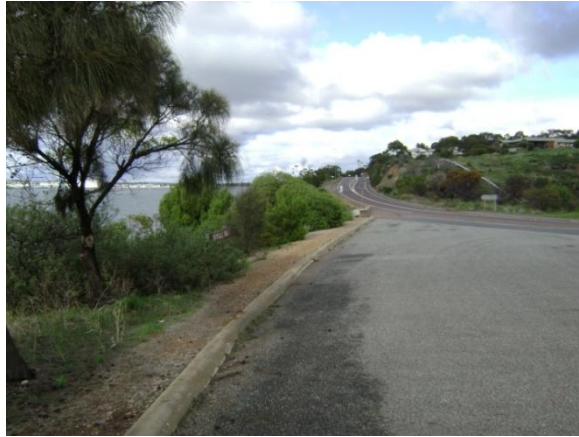
- Delineation of path required through the information bay car park and kerb ramps upgraded to current standards. Additional seating to be provided in car park area.

Information Bay Car Park

- 1.2 Upgrade general appearance of the information Bay area including additional seating and directional marking for walkers.**
- 1.3 Provision of suitable connection to the path from Kurla Street footpath including provision of gap in guard fence for access.**

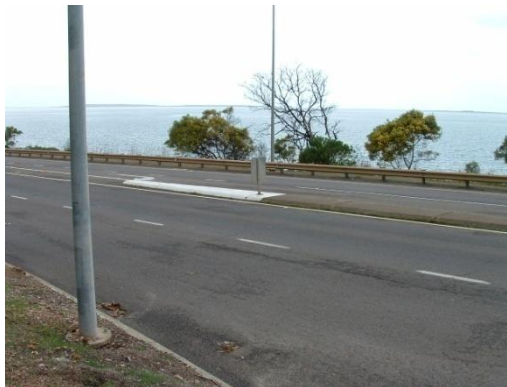
- Trimming of vegetation is required along section from information bay to Kurla Street to achieve 2m clearance.
- Guard fence along the Lincoln Highway restricts access to the path for users coming from the Kurla Street area. A formal crossing point should be established to overcome this and a gap provided in the guard fence.

Proposed Crossing Point near Kurla Street

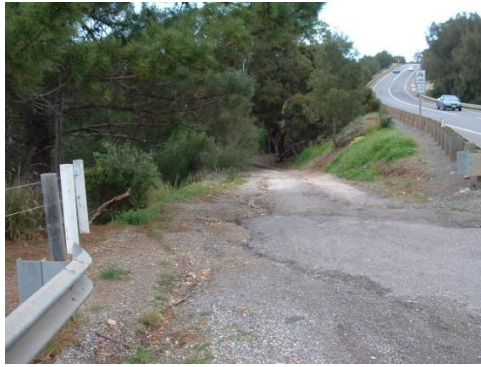
- Access road down to the 'Oasis' picnic area should be asphalt sealed to prevent ongoing maintenance issues and to improve exit from the site. One side of the sealed path should be delineated for use by path users.
- Access path from the 'Oasis' back up to the Lincoln Highway should be converted to a ramp for its full length (ie steps removed) to improve access for prams and sealed to a minimum 1.2m in width. This section has a 10 – 20% slope and paving of the existing 20m stepped section would reduce slip hazards to walkers. Replacement of existing retaining wall along the sides may be required to achieve a 1.2m width. Slopes will still be greater than minimum recommended for wheel chairs and bicycles.

'Oasis' Road Down track

- 1.4 Asphalt sealing of the access road down to the 'Oasis' picnic area with one side of the sealed road delineated as part of the Parnkalla Trail.**
- 1.5 The path from the 'Oasis' back to Lincoln Highway be converted to a ramp (steps removed) to improve access for prams. Paving of the current step section (20m) and replace retaining walls were necessary.**

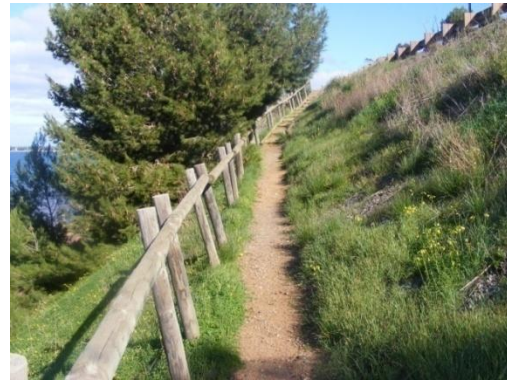
'Oasis' – Trail up track

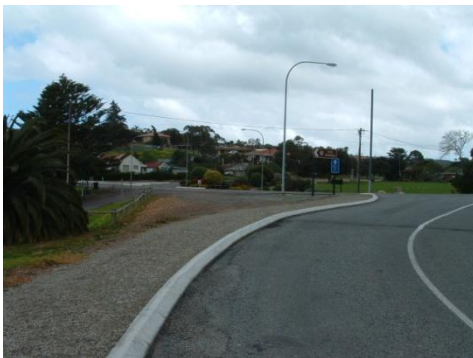
- i. Divert cyclists/prams etc around the top via Lincoln Highway and maintain existing stairway to the bottom.
- ii. Divert cyclist around the top and prams/wheelchairs around the bottom behind the existing sheds.
- iii. Construct a boardwalk/bridge from the 'Adelaide' to the path adjacent the existing toilet block.

Proposed detour for cyclists/prams

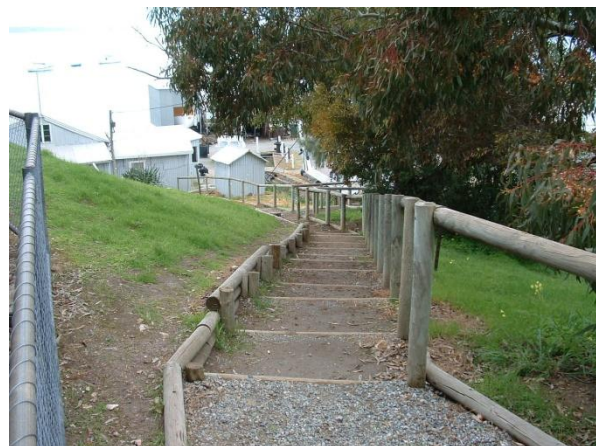
Existing steps down to path.

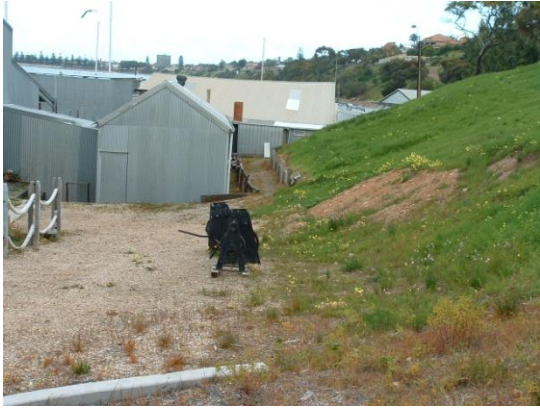
The Axel Stenross Museum committee have also approached Council previously for the provision of a toilet block in the vicinity of the museum which would serve museum patrons and users of the boat ramp. For comparison the recently constructed composting single unisex toilet block at the RSL cemetery cost \$32,000 which included \$27,000 for supply and installation of the system and structure and \$5,000 for paving and fit out. Due to the proximity of the sea it is assumed that a holding tank and pumping system would be required for any new toilet block installed near the museum, this system would cost an extra \$8,000, ie total estimated cost would be in the order of \$40,000.00

Proposed location of new toilet block

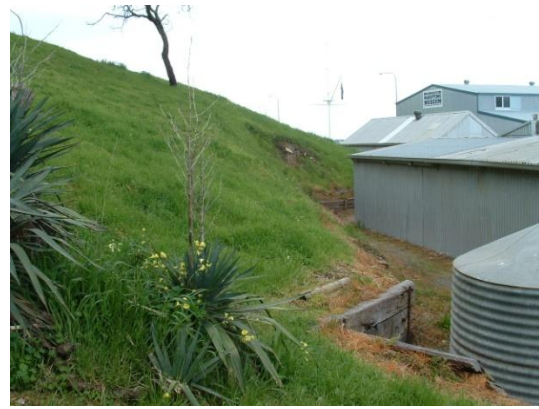
Path running behind museum to existing toilet

Upgrading of the path from the museum to the toilet block including provision of retaining walls is estimated to cost \$20,000 consisting of \$12,000 for retaining walls and \$8,000 for excavation and preparation and therefore would be a cheaper option than construction of a new toilet block and removal of the existing block.

- 1.6 The existing toilet block at Axel Stenross be retained and a path suitable for wheel chair access be established from the Museum and boat ramp to this toilet block.**

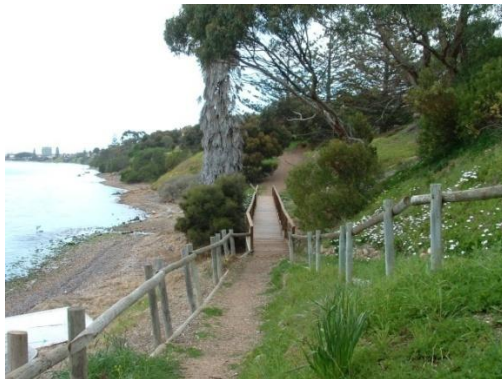
- Section from Axel Stenross car park area to Happy Valley Spring includes sections of steps and narrow path/bridge widths.

Footbridge – Happy Valley Spring

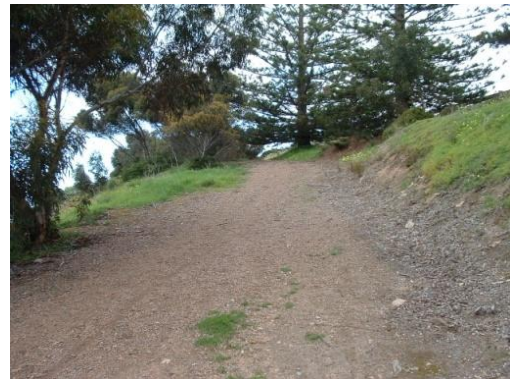
Path up to Lincoln Highway

- Sealing of the steep section from Happy Valley spring back up to Lincoln Highway would improve accessibility.
- The ramp from First Landing site down to Happy Valley Spring requires regravelling.
- Section adjacent Lincoln Highway to Limani's has a number of areas where width is reduced to less than 1.0m preventing access by prams/pushers. A solution would be to construct short sections of boardwalk at these 'squeeze' points (6 Total) which would double as viewing areas.

- 2.1 Path to be sealed at a minimum of 1.2m, preferably 2.0m wide along the section from the Happy Valley Spring footbridge to the start of the top path adjacent the Lincoln Highway. Direct cyclists onto Lincoln Highway for this section through appropriate signage.**

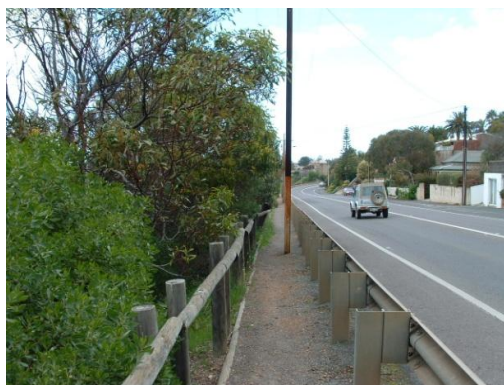
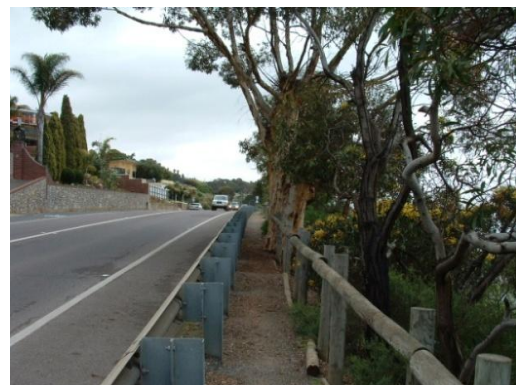
Typical narrow sections adjacent Lincoln Highway

- 2.2 Regravelling and possible sealing of sections from First Landing and Stenross Toilet block to the footbridge at the Happy Valley Spring.**
- 2.3 Local widening/viewing areas be constructed at the six (6) obstructions along the top path adjacent the Lincoln Highway.**

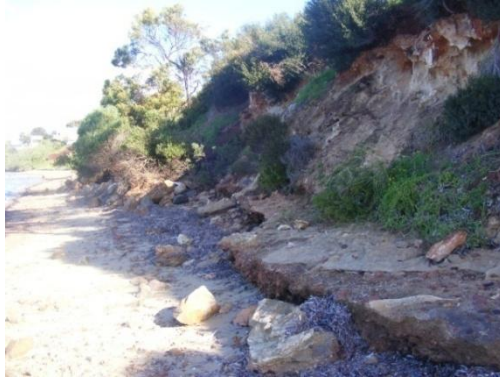
- The beach area is only accessible during low tides. It was proposed to construct a boardwalk along this section linking the foreshore to the museum in the years 2011 – 2013 of Councils Strategic Plan. This may be impractical due to exposure to the open sea and associated high maintenance costs. An alternative would be to construct a rock protected raised footpath along this section of the existing path adjacent the Lincoln Highway between the fig trees (Tasman Tce) and Axel Stenross Museum. This would also provide protection of the coastline from further erosion. Further investigation into this proposal is required.

Typical area along foreshore

- 2.4 Concept design plans be established for the construction of a rock protected path running parallel to the foreshore between the fig trees (Tasman Terrace) and the footbridge below the First Landing site.**

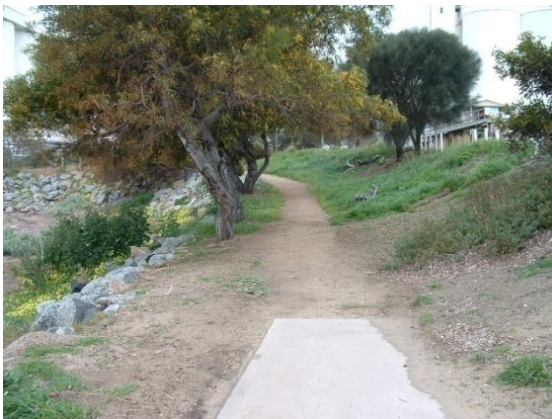
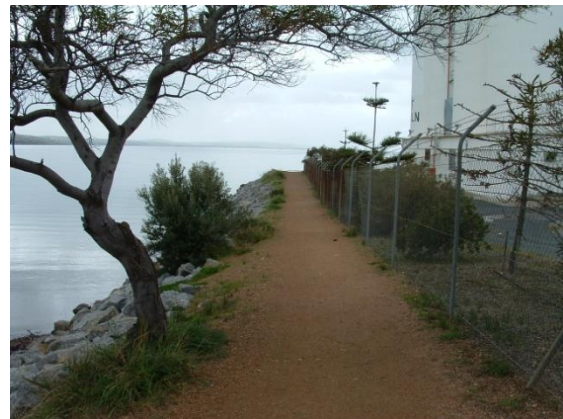
- Issue with sand covering the path between the yacht club and the Boston requires ongoing maintenance.
- The path reverts to a gravel path from the Boston Hotel and around the perimeter of the silos up to the No.1 wharf, as this is a heavily trafficked path it is recommended that this section be asphalt sealed.

Section of path adjacent silo complex

- 3.1 Sealed at a minimum of 1.2m, preferably 2.0m wide along all sections that are currently unsealed.**
- 3.2 Provision of complying bridge structure over the oil pipeline near Kirton Jetty.**
- 3.3 Review and upgrade of pavement markings and signage through the wharf area.**

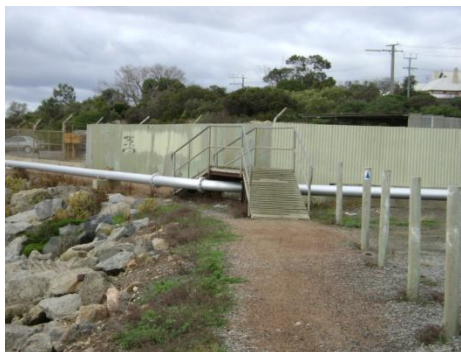
- The section of the trail through the wharf area is located on State Government land being Minister for Transport/Flinders Ports. There are issues with pedestrian traffic mixing with wharf traffic through this section. Formalising of paths and review of signage to improve safety through the Wharf Area is recommended.
- The path is gravel from the wharf area to the Kirton Jetty and a bridge structure over the oil pipeline near the Kirton Jetty restricts access for wheel chairs/prams.

Steep ramp over oil pipeline

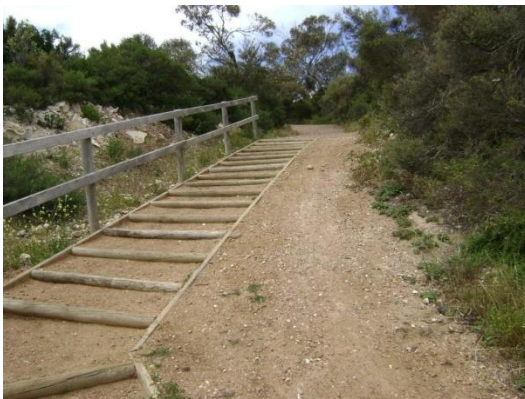
- The stair section leading from the Kirton jetty car park eroded. Steps require paved infill and adjacent path rehabilitated. Alternative access for wheel chairs should be provided utilising the existing paved path adjacent the access road to the car park and new connecting path established.

Existing stair section

- 4.1 Upgrade existing steps from the Kirton Jetty carpark (paved infill) and adjacent path rehabilitated. Provide alternative access for wheel chairs utilising the existing paved path adjacent the access road to the car park and new connecting sealed path.

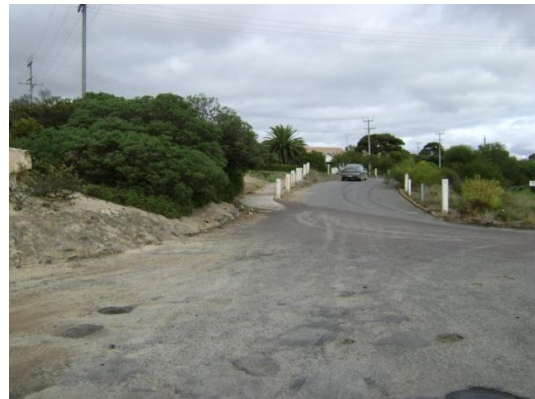
Existing ramp section

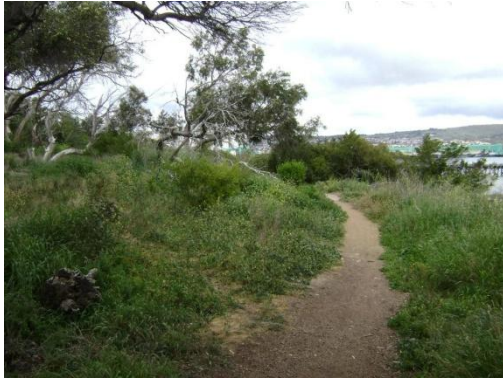
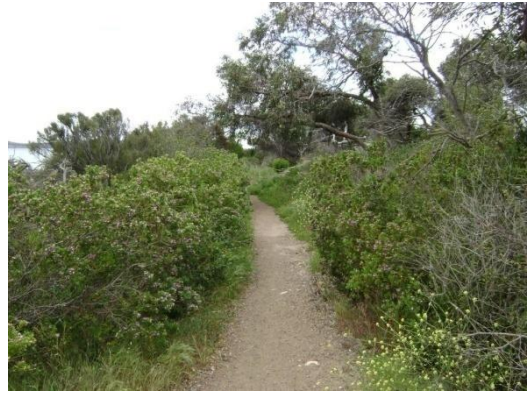
- The first section from the Kirton Jetty to the old ETSA site is heavily infested with woody weeds and will require major clearing and a follow up revegetation program in accordance with the Eyre Native Seeds report, attachment.

Extensive woody weed infestation through section adjacent Gawler Terrace.

- 4.2 Remove weed species and replant native vegetation between Kirton Jetty and the old ETSA Power site, undertake local weed control and replanting on remaining sections as per Eyre Native Seeds report.

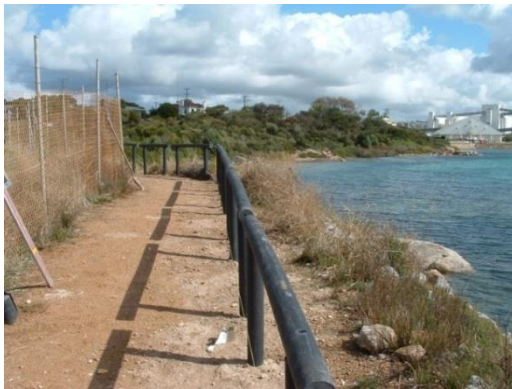
- Section around the ETSA site should be sealed in conjunction with the housing development at the old ETSA site.

Path and railing around old ETSA site

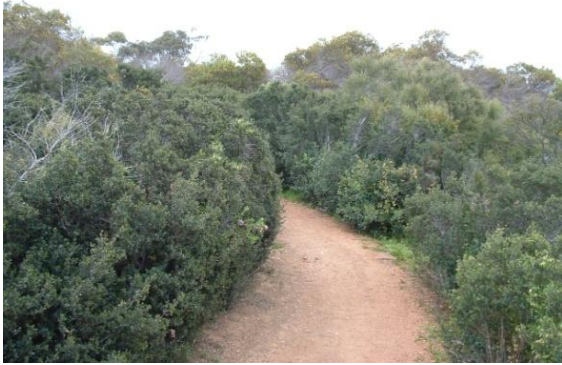
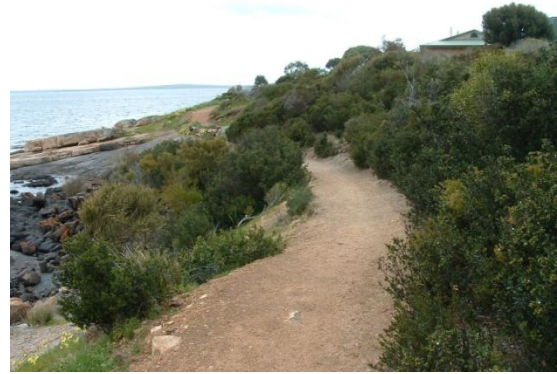
- An alternative path should be provided for prams/wheelchairs etc to bypass the narrow winding section between Snapper Rock and the Marine Science Centre.

Existing path from Snapper Rock to Marine Science Centre

- 4.3 Upgrade and seal the section from the Kirton Jetty to Snapper Rocks to 2.0m wide.
- 4.4 Construct and seal diversion path from Snapper Rock Car park to Marine Science Centre using existing Council fire track (150m) at 2.0m in width. Maintain the existing 1.0m wide unsealed path along the coast from Snapper Rock to Marine Science Centre.

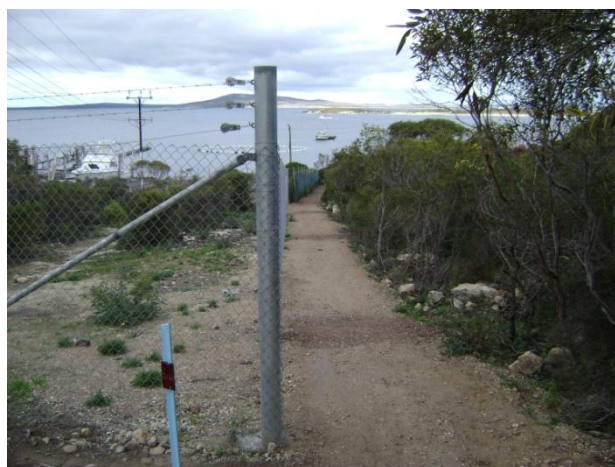
- Scour protection and sealing of the steep section adjacent the slipway is recommended.

Steep descent adjacent slipway

- 4.5 Seal the path from the Marine Science Centre to Slipway Road (800m), minimum 2.0m wide and seal the path from Slipway Road to within 400m of Mundys Mooring (850m), minimum 2.0m wide.

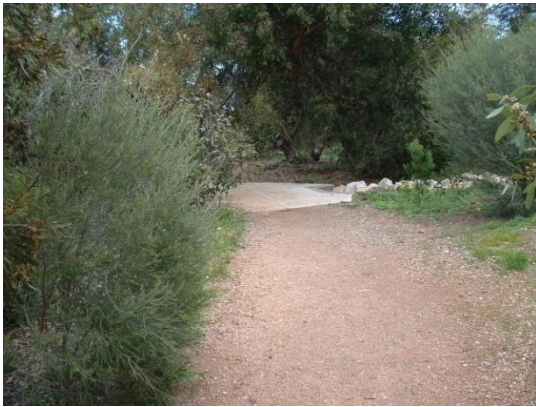
- Bypass of last 400m narrow winding section prior to Mundy's Mooring is recommended.

Start of narrow winding section

- 4.6 Provide a link from the Parnkalla Trail onto Adelphi Terrace at a point 400m from Mundy Mooring and seal the footpath adjacent Adelphi Terrace from this point to the Mundy Mooring carpark. Restrict access along the 400m section of the Parnkalla Trail from this link path to Mundy's Mooring Reserve and maintain this section as existing 1.0m wide unsealed path.

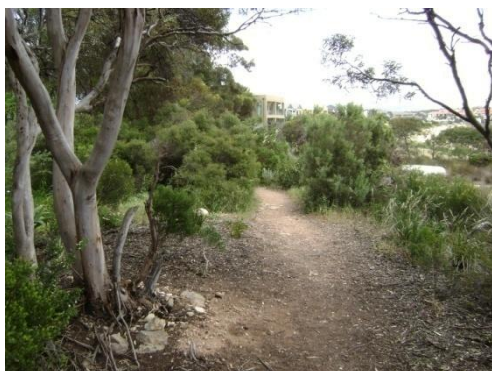
- Some vegetation trimming and resheeting required along the first 300m.

First section from South Point Drive

- 6.1 Regravelling of selected sections of the path to cover tree roots and sandy sections.**
- 6.2 Suitable accesses be provided to the beach section of the path and existing fencing be repaired as required.**
- 6.3 Installation of signage and pavement marking through the lawn and car park areas to direct walkers to the Billy Lights Point look out.**
- 6.4 Section from Boat ramp car park to lookout requires gravelling and fencing/signage to keep users to the correct alignment.**

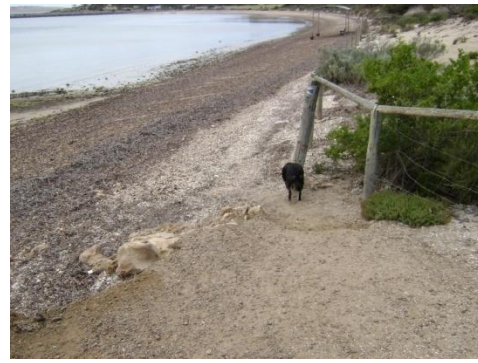
- Where the path goes from the hard surface to the beach steps and/or ramp required.

Steps required down to beach

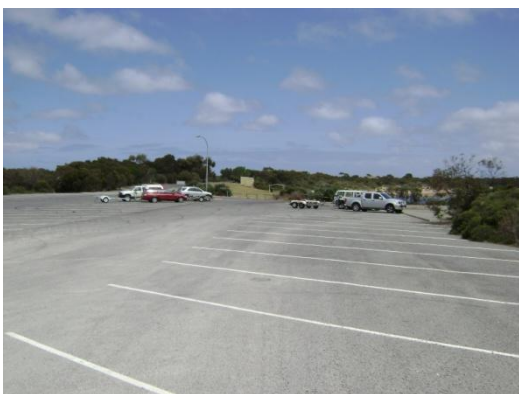
Delineation required through car park

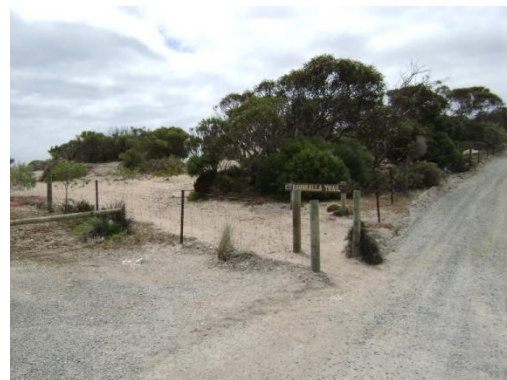
Path requires gravelling and direction indication/fencing

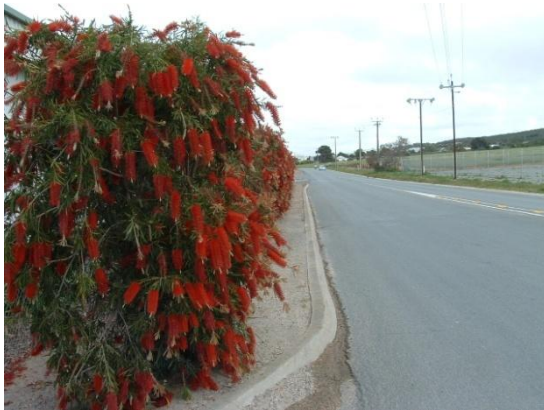
- The first section adjacent Marnikol is restricted by vegetation not properly delineated and competes with car parking.

Path restricted by vegetation competes.

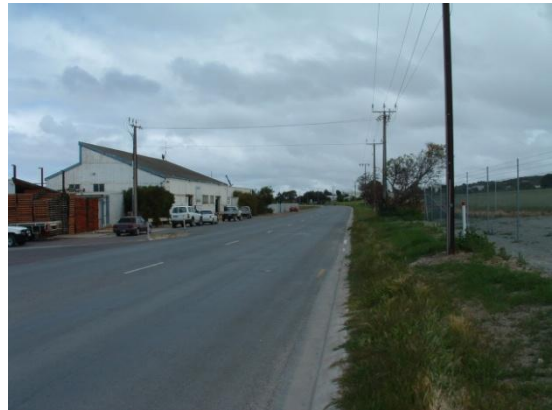
Path not delineated and car parking

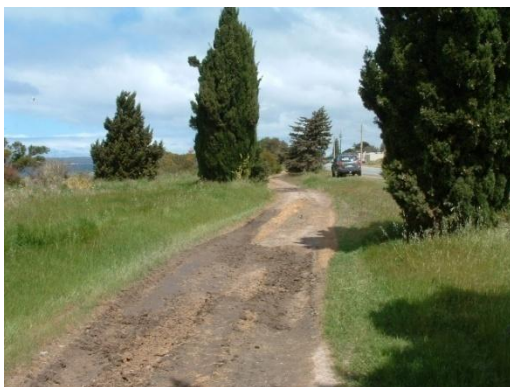
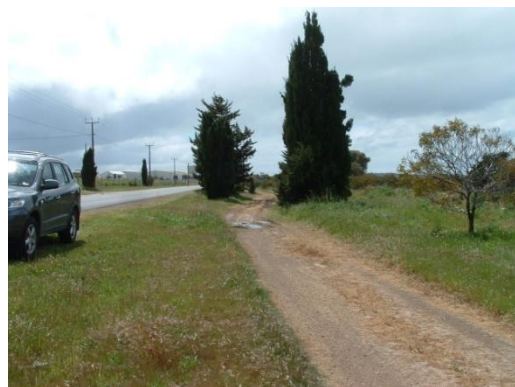
- Sections adjacent culvert outlets need improvements (pipes and lifting) to remove ponding problems on the path – 4 locations.

Typical section in low lying area

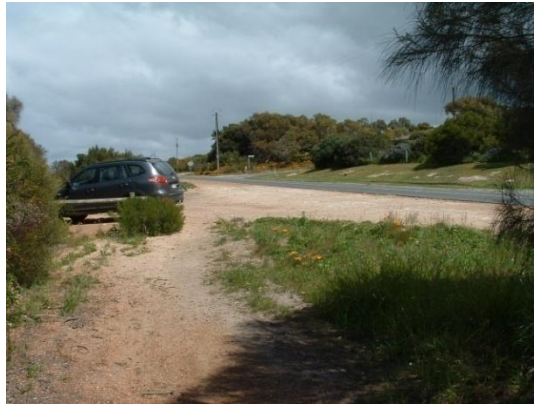
- Consideration should be given to upgrading this section of the path to a sealed dual use path to within 400m of Council Boundary where a defined point exists to link cyclists back to Proper Bay Road.

Link back to Proper Bay Road for cyclists
