CITY OF PORT LINCOLN

PARNKALLA TRAIL 10 YEAR STRATEGY 2008 - 2018

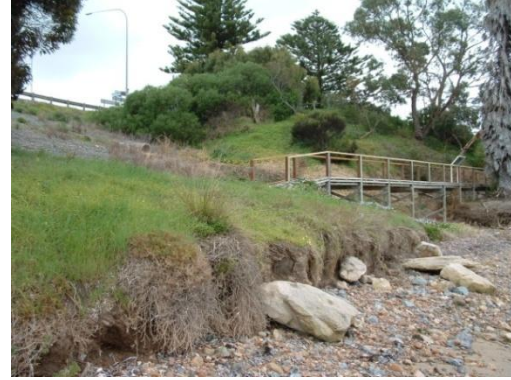
Possible connection point back to trail

- Construction of a footpath in Shaen Street is on Councils 2009/2010 footpath program, this path should be connected to the Walking Trail at the First Landing site.

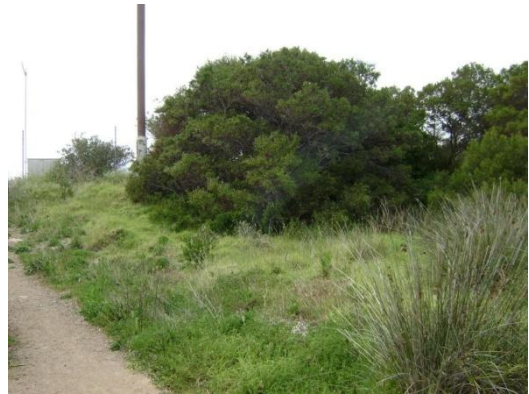
Proposed car park area adjacent old ETSA site

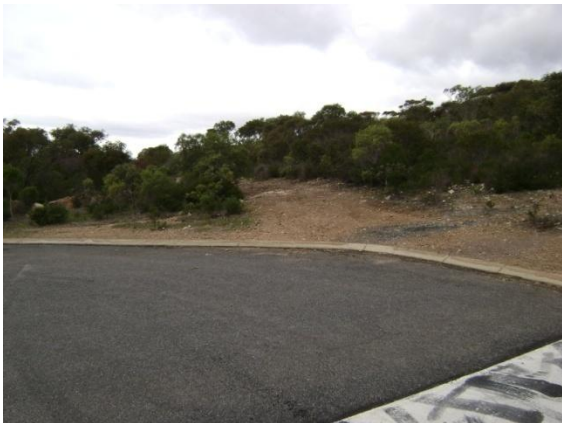
Existing path from Snapper Rock to Marine Science Centre

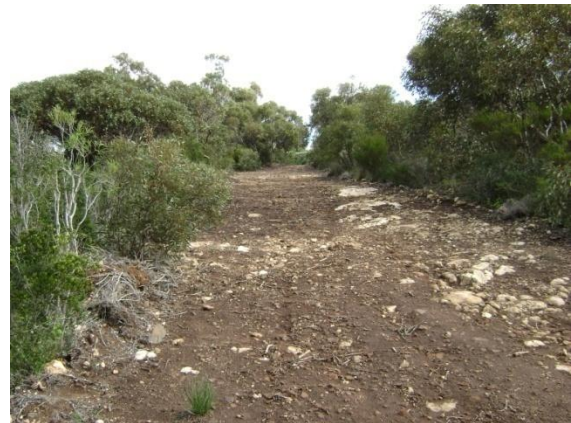
Proposed alignment of new path from Snapper Rock to Marine Science Centre.

- Scour protection and sealing of the steep section adjacent the slipway is recommended.

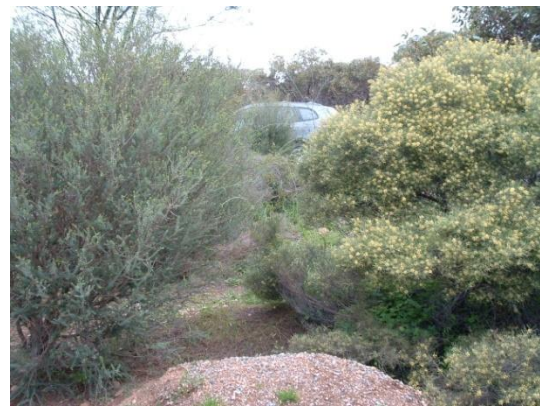
Proposed bypass of narrow section to Adelphi Tce

- Bypass of last 400m narrow winding section prior to Mundy's Mooring is recommended.

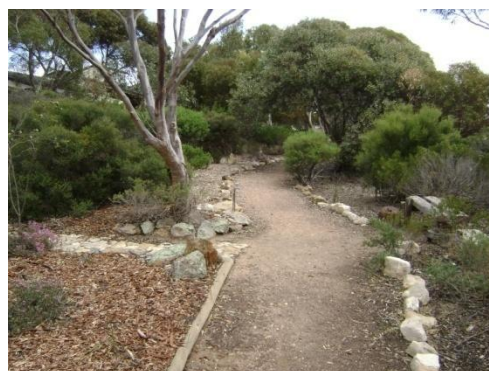
Delineated section past houses

- Minor resheeting required over tree roots and sandy areas between South Point Drive and the vehicle access point (from St Andrews Terrace).

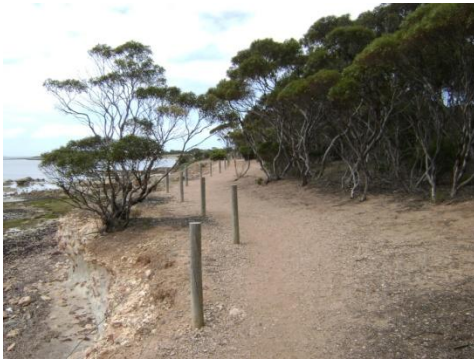
Wide section adjacent coast

- Fencing along beach section needs to be replaced/repaired.
- Access points down to beach from St Andrews Terrace need to be upgraded.
- Signage needed in lawn area at Billy Lights Point to direct walkers to the lookout. A separate walking area to be marked through the car park.
- Extra markers/fencing required along last section to keep trail users on the correct alignment.
