MLM/23-0205

26 September 2023

KERB PROTUBERANCE TO OUTDOOR DINING AREA 80 TASMAN TERRACE, PORT LINCOLN

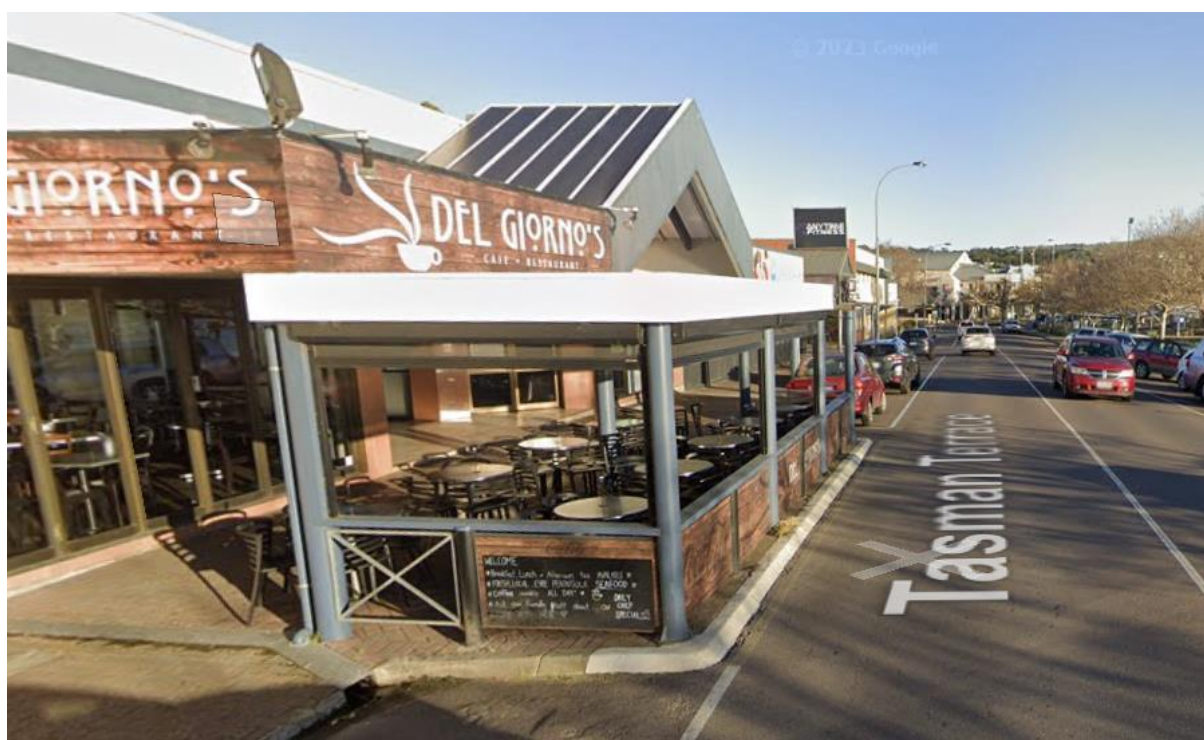
A similar facility has been provided for an existing café adjacent the proposal, as illustrated in Figure 1.

Figure 1: Existing outdoor dining area (source: Google Streetview)
